PATHOGEN CONTROL IN HOSPITAL DOMESTIC WATER SYSTEMS - A NEW APPROACH

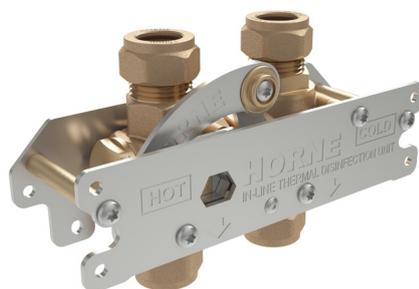
Figure 1. Horne's patented In-Line Thermal Disinfection Unit (ILTDU)

The resulting product design, the Horne In-Line Thermal Disinfection Unit ILTDU (Figure 1), now has patents granted and applied for around the world.

The design is very clever, but simple, and utilises two 3-way ball valves, connected by a bridging piece, that rotate by a single gear mechanism or 4-way link. Shifting the mechanism rotates the hot water ball valve through 180° and, simultaneously, rotates the cold water ball valve through 90°. This repositioning of the ball valves opens a temporary pathway from the hot water supply to the cold water drop as shown in Figure 2 below.

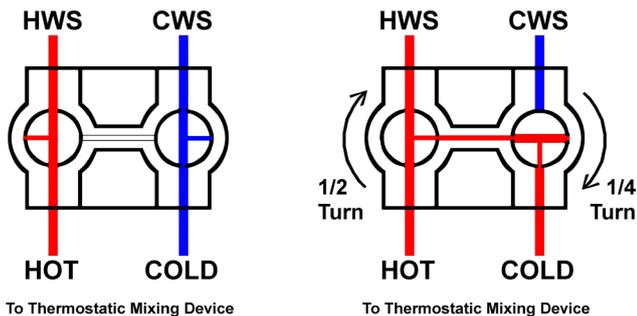
Figure 2. Hot and cold water pathways in Passive (LH) & Disinfecting (RH)

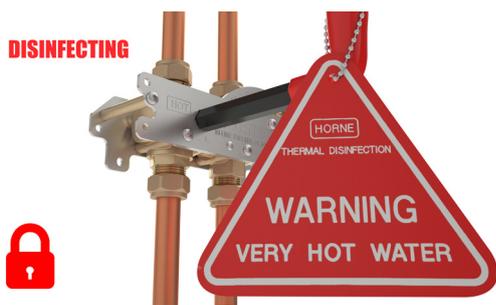
Figure 3. In Disinfection Mode, the key and its warning sign cannot be removed

A special key is used to operate the mechanism. A large red warning triangle attached to the key alerts users and nearby personnel and patients to the risk of scalding. When in Disinfection Mode, the key is locked in position and cannot be removed - therefore the Very Hot Water warning sign is permanently present (Figure 3). Only when the device is returned to Passive Mode can the key be removed.

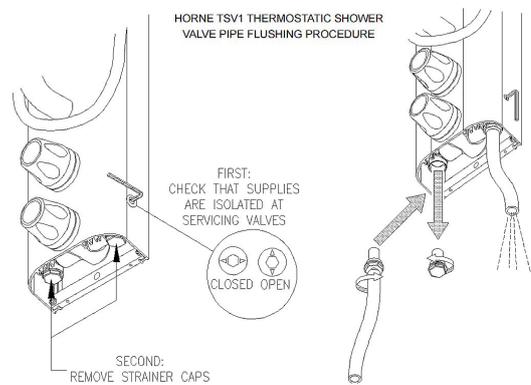
Figure 4. Flushing at elevated velocity through a Horne TSV1 shower panel

Hans-Curt Flemming⁶ stresses that disinfection is not cleaning and therefore dead biofilm left after disinfection should be removed, as far as possible, from the internal pipe walls. A practical means to remove this is by flushing the water system at an elevated velocity, which abruptly increases shear stresses at the pipe walls, eroding and detaching the biofilm¹³. The water flow then carries the suspended bacteria concentration away to drain. Although this shearing will never entirely remove the biofilm, it will diminish it to a pre-dispersion state, reduce planktonic motility and thus have a positive effect on overall water quality. An example is given below, Figure 4, showing how to flush at elevated velocity via a Horne TSV1 shower panel.

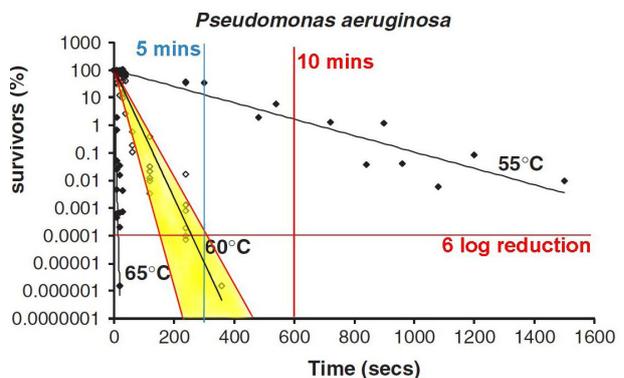
Figure 5. Annotated thermal inactivation curve for Pseudomonas Aeruginosa from Spinks et al, 2006¹⁴.

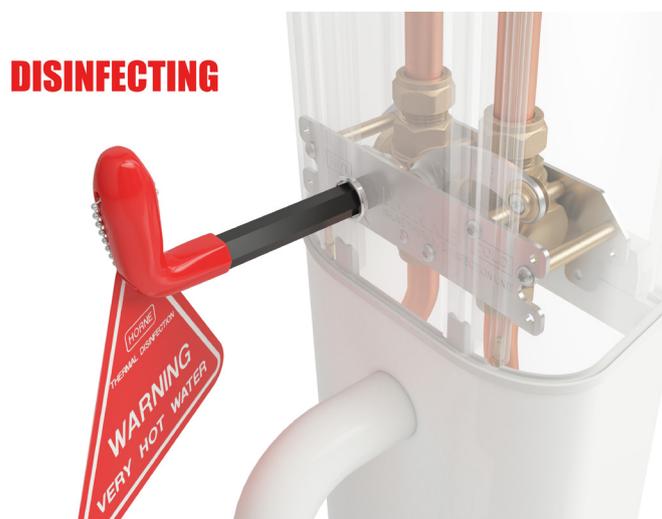
Figure 6. Horne ILTDU integrated into TSV1 shower panel with adapted pipe cover

A major benefit of the ILTDU is that it can be installed up-stream of any make of TMV, tap or shower – i.e. wherever there is a risk of colonisation of P. Aeruginosa, L. Pneumophila, S. Maltophilia or any other pathogen that survives in the water system, it can be thermally disinfected with the available hot water supply. The ILTDU is available from Horne Engineering Ltd as a stand alone unit, for fitting in new or retrofit installations. It is also integrated into Horne's range of TSV1 surface mounted shower panels (Figure 6, overleaf). Periodic ILTDU disinfection is easily achieved and continued patient safety ensured.
